Prolonged generator lifetime after resolving persistent vibration issues

Vuosaari A in Helsinki,
Finland, producing electricity
and heat

CASE Helen

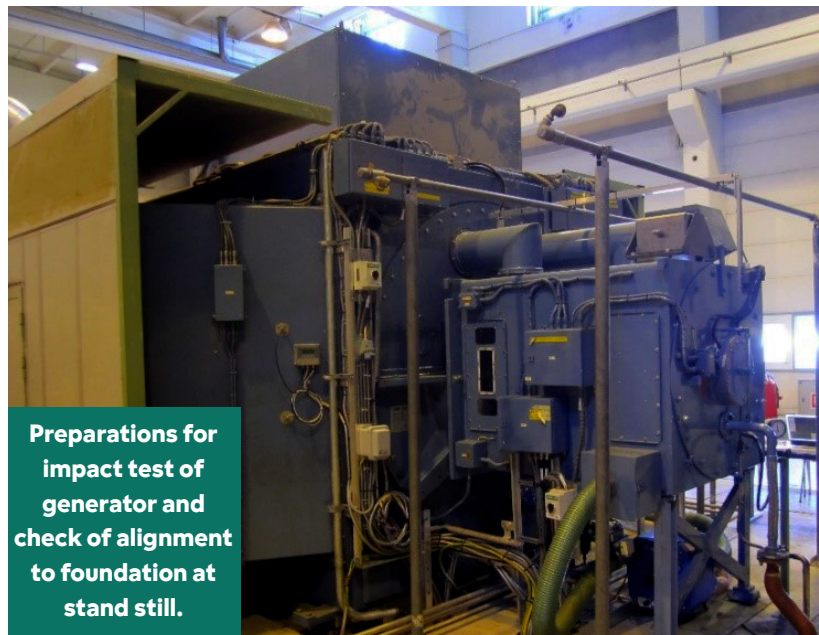
Preparations for impact test of generator and check of alignment to foundation at stand still.

Based on the initial findings, Fortum eNext proposed to the customer an action plan, which was also executed during spring 2015. It was then discovered that the generator was standing even less on its feet than seen before. Additionally, the so-called impact test (knocking tests) revealed that the structure would very easily start vibrating; the resonance frequency rose close to 50Hz.

“By performing knocking tests on the generator exciter housing we found resonances that could easily be excited during operation,” Gabor Csaba notes.

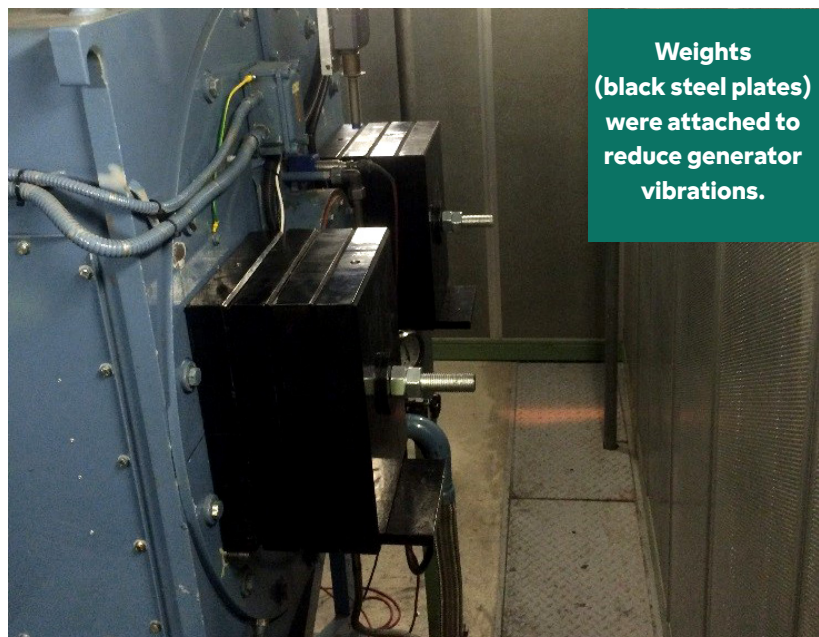
Weights (black steel plates) were attached to reduce generator vibrations.

After analysing all the findings, Fortum eNext experts proposed to re-align the generator and to attach a 400kg weight onto the far end of it. Both actions were implemented, and as a result the vibration was reduced – but not back to the level before year 2008. The downside to this was that the additional weight made maintenance of the generator more difficult.

Finally, the additional 400 kg weights could be removed, giving less static stress on the exciter housing and making maintenance a lot easier.

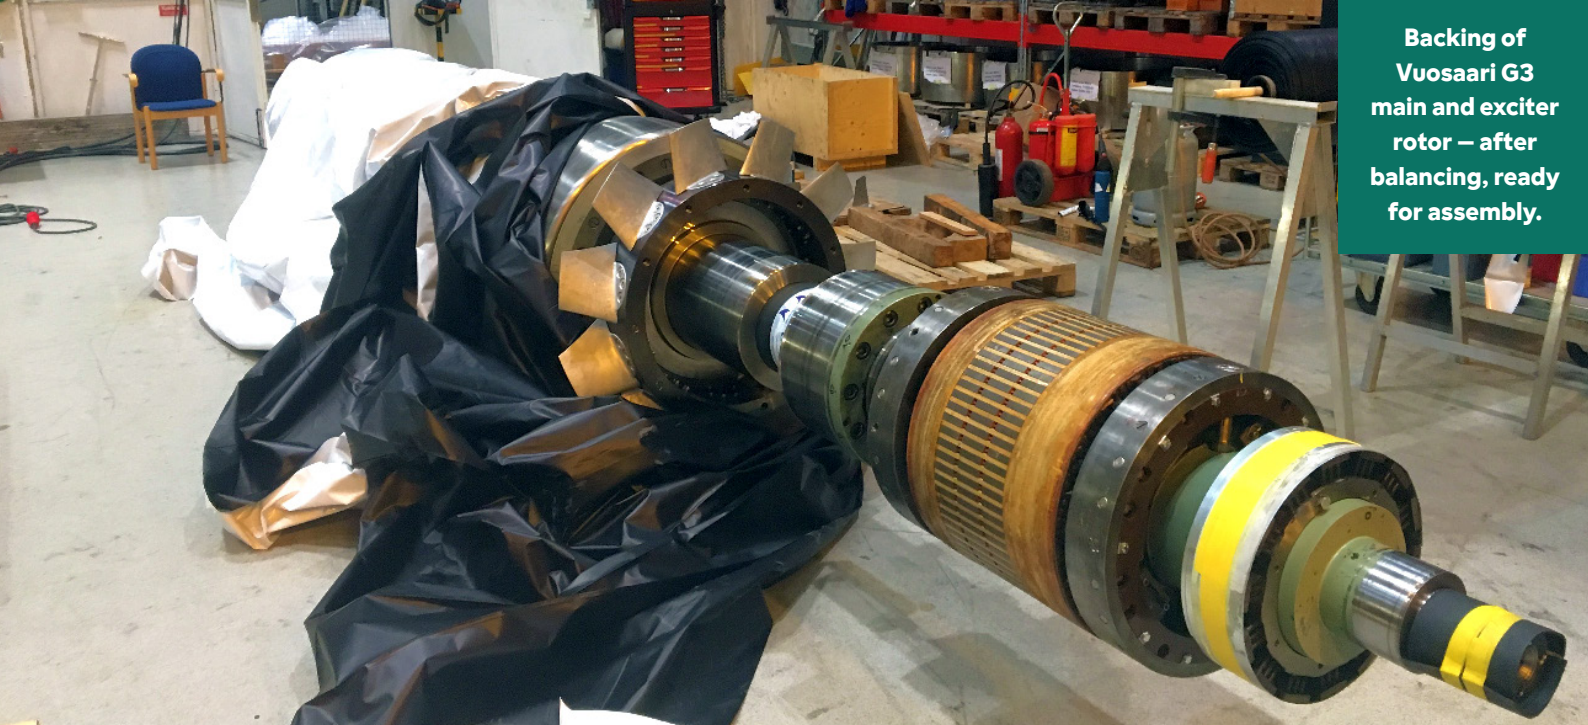
Backing of
Vuosaari G3
main and exciter
rotor – after
balancing, ready
for assembly.

In summer 2018, Fortum eNext returned to Vuosaari A site to implement the planned electrical connection upgrades. The repairs were done at Fortum's own generator workshop in Västerås, Sweden, where also balancing of both the main rotor and the exciter rotor was done in the high-speed balancing facility - the only independent high-speed balancing facility in the Nordic countries. Finally, both parts were aligned together before sending them back to Finland for installation.
